CHAPTER TWELVE

DEFICIENCIES OF MAINTENANCE, FUTURE COSTS AND ALTERNATIVE PROGRAMMES FOR COMMERCIAL AND CRUISING WATERWAYS

Deficiencies of Maintenance, Future Costs and Alternative Programmes for Commercial and Cruising Waterways

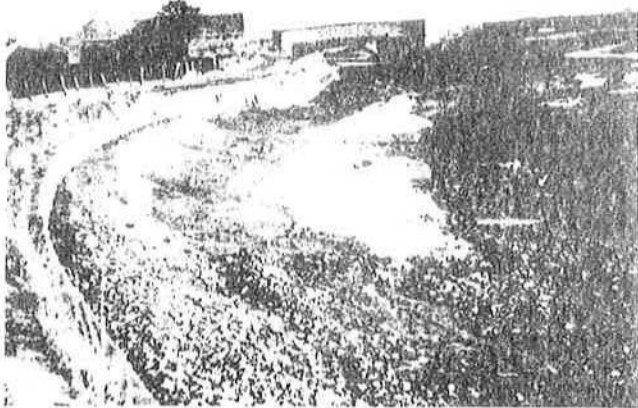
Plate 12.1 A dewatered length of the Leeds and Liverpool Canal at Huncoat (PFP)

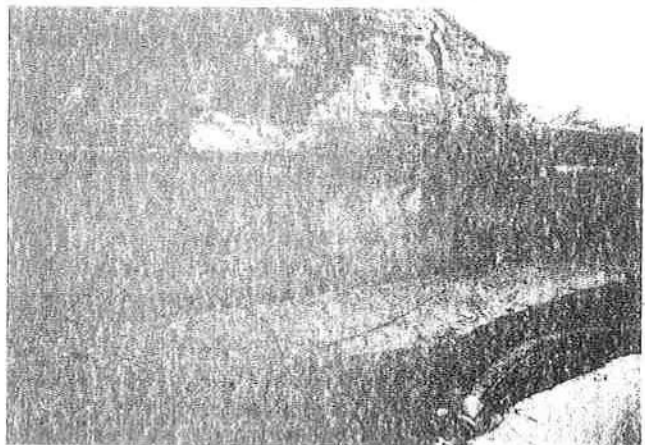
Plate 12.2 Deterioration of brickwork below water level seen at Hampton bridge (Llangollen Branch of the Shropshire Union Canal) while dewatered for repair of a nearby breach. (PFP)

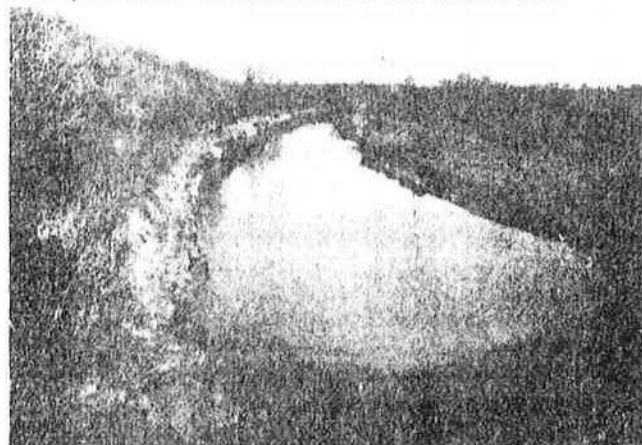
Plate 12.3 The Grand Union Canal near Long Itchington, showing a towpath virtually impassable due to erosion and damage by stock on the offside. (PFP)

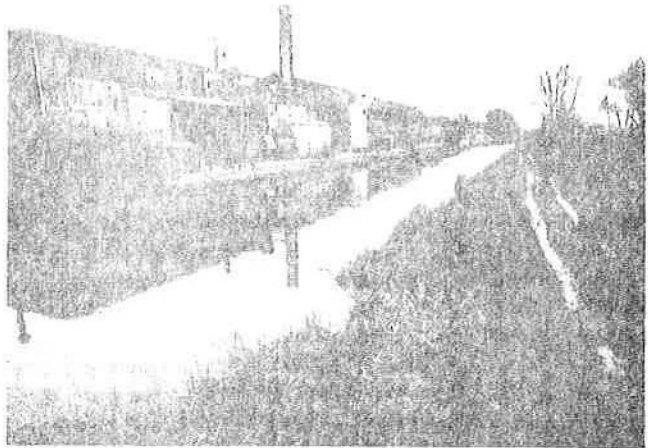
Plate 12.4. Reed growth providing natural protection to the towpath bank — Oxford Canal (South) (PFP)

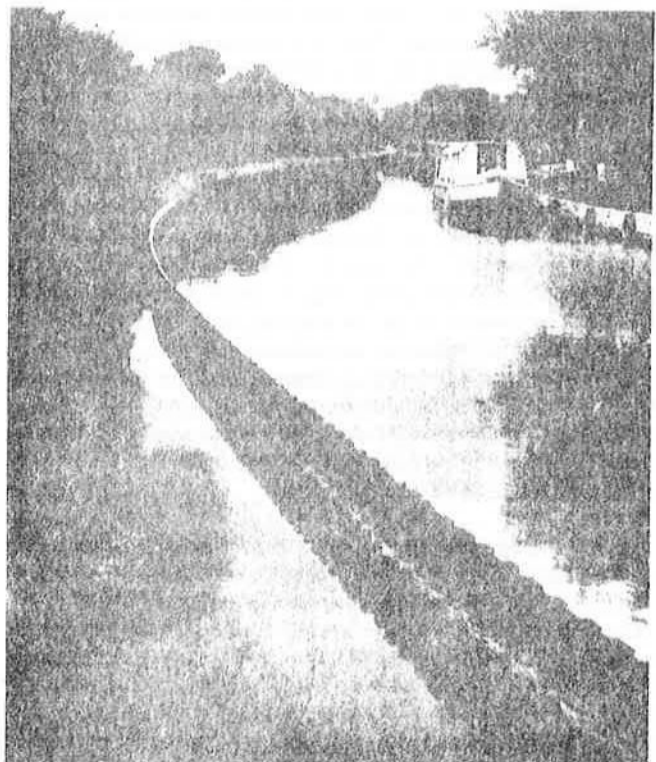
Plate 12.5 Re-protecting an eroded bank on the towpath side of the Oxford Canal (North) (PFP)

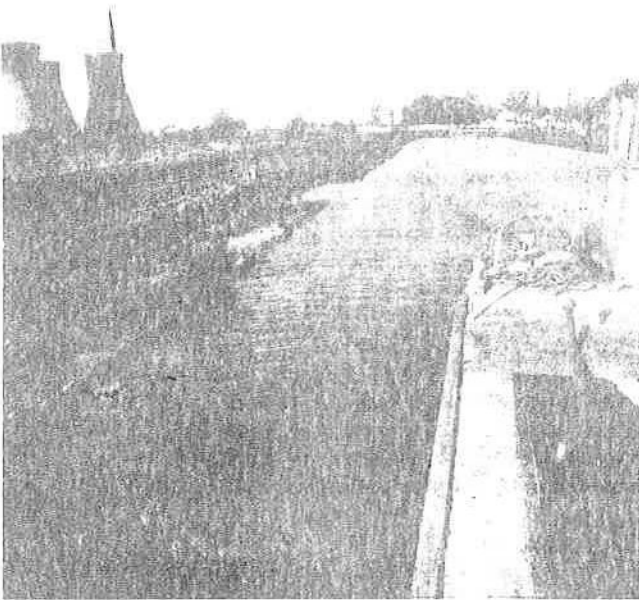
a) Failed piling and extensive erosion into an embankment – Sheffield and South Yorkshire Navigation (PFP)

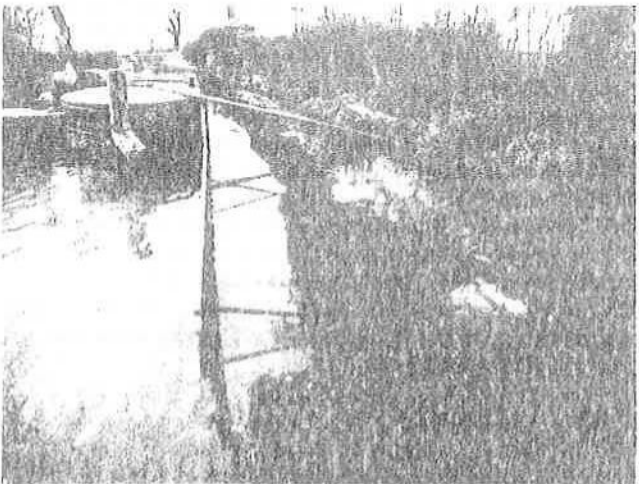
b) A towpath embankment with virtually no freeboard now being re-protected and back filled – Grand Union Canal. (PFP)

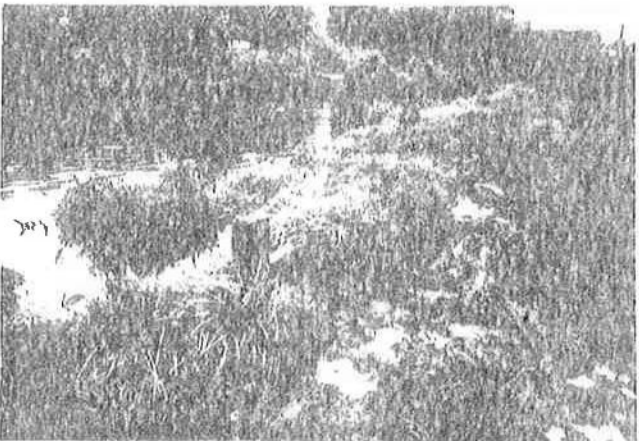
c) Temporary repair to an offside embankment, only the plank prevents overtopping – Staffordshire and Worcestershire Canal (PFP)

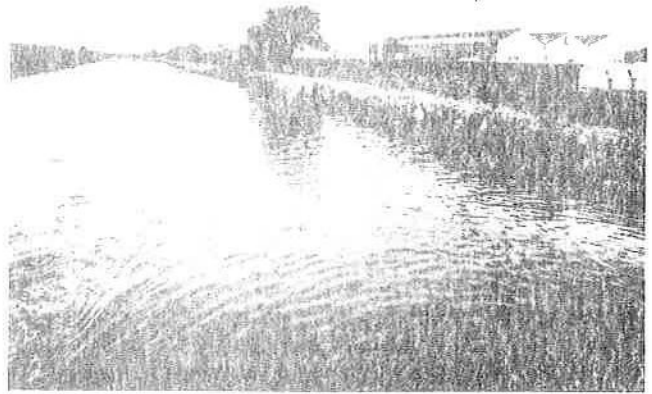
d) Advanced erosion of a towpath threatening the foundations of a boundary wall – Sheffield and South Yorkshire Navigation. (PFP)

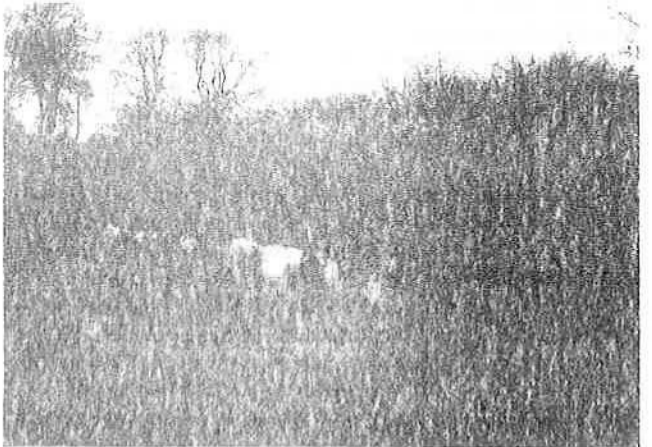
e) An offside embankment with low freeboard, vulnerable to stock damage – Macclesfield Canal. (PFP)

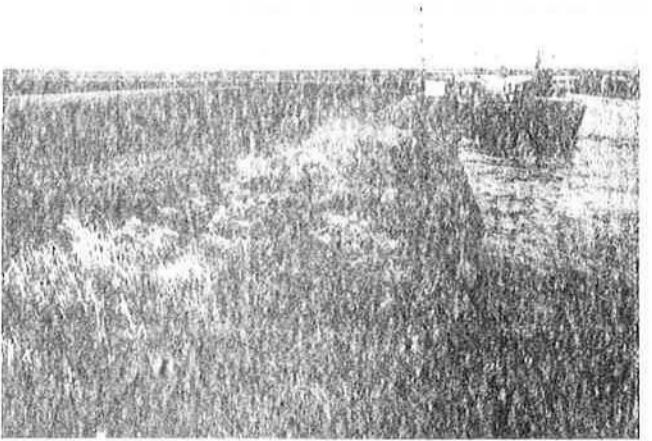
f) Support to the toe of this piling on the Aire and Calder Navigation has been undermined, leading to failure. (PFP)

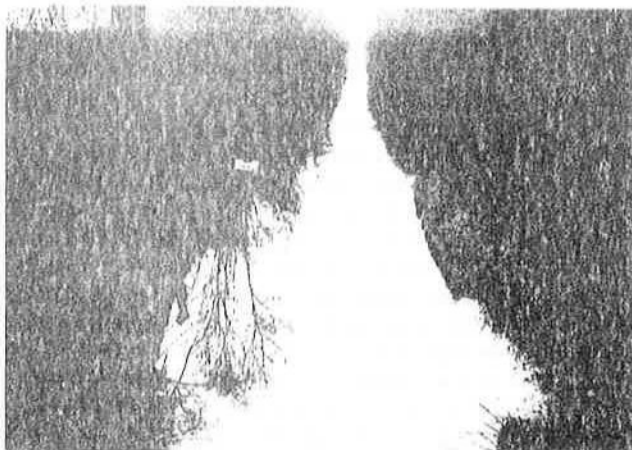
Plate 12.7 Extensive erosion following failure of dry-stone walling on the towpath side – Shropshire Union Canal (PFP)

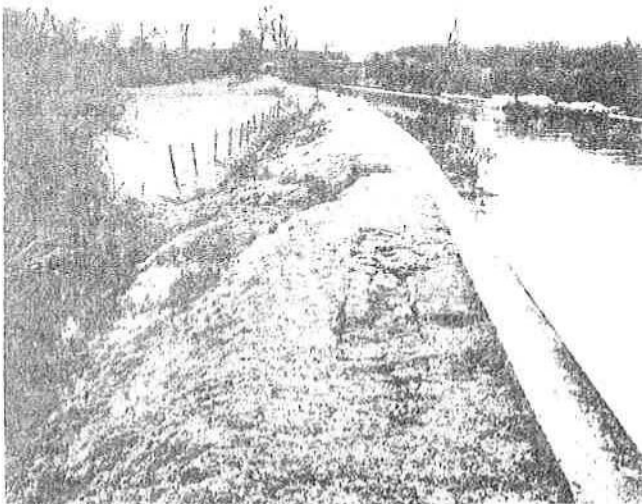
Plate 12.8 This embankment on the Grand Union Canal has a history of persistent leakage problems (PFP)

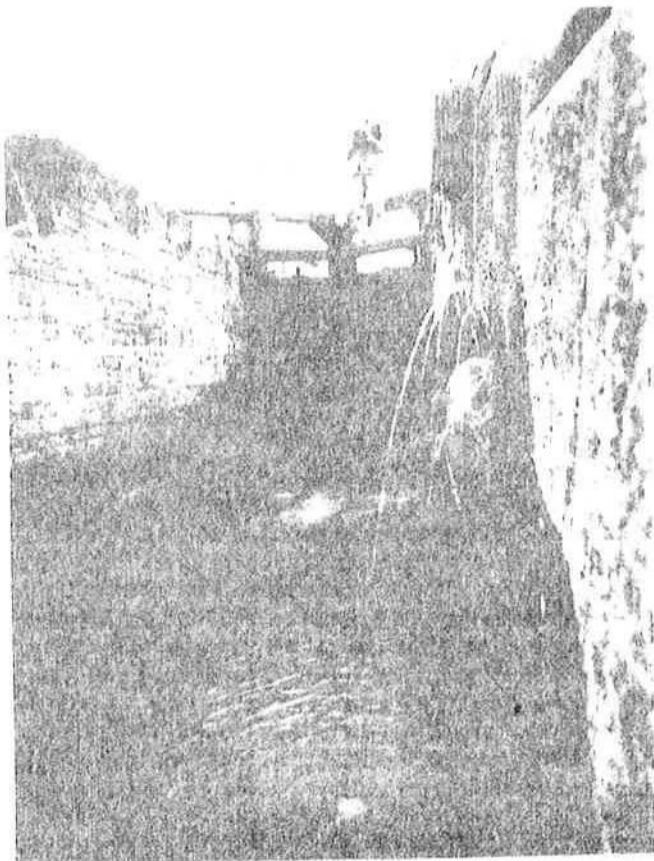
12.4.26 The main unpredictable cost for lock chambers is that of grouting cavities behind the walls when lack of pointing has allowed the water to wash out material, causing leaks and in some cases instability of the wall. It is usually possible to see when this problem exists by observing water runs on filling and then emptying the lock, but the cost of treatment depends largely on the volume of the hidden cavities to be filled. The amount of money involved is relatively small, and we have included an allowance which we consider appropriate.

Plate 12.9 Water pouring out from cavities behind a lock chamber wall — Llangollen Branch of the Shropshire Union Canal (PFP)

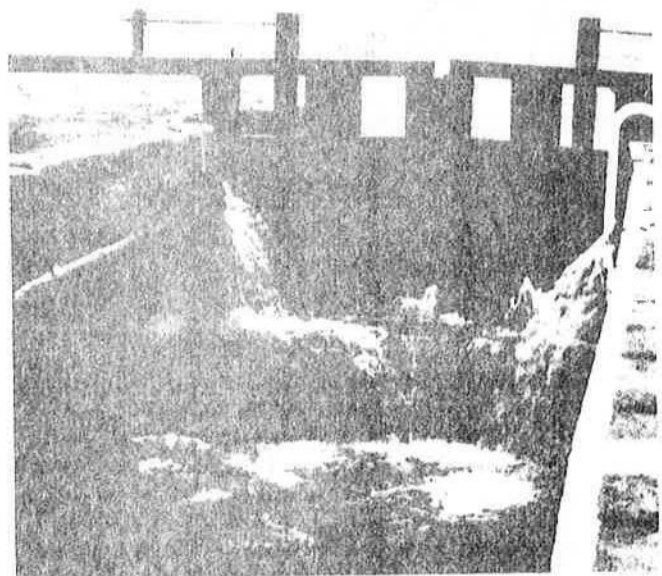
Plate 12.10 Leakage between gate heel posts and chamber quoins, etc. — Leeds and Liverpool Canal (PFP)

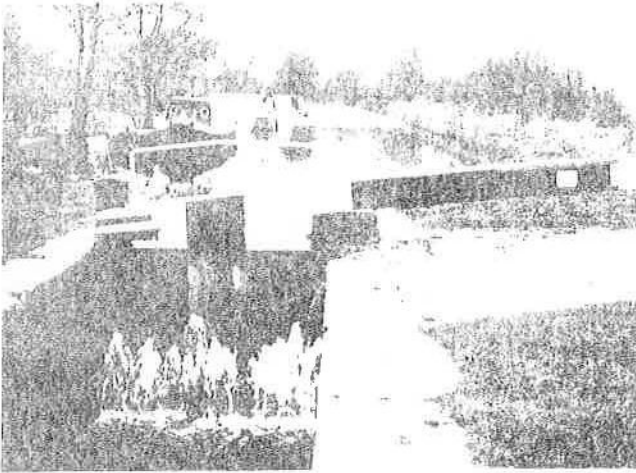
Plate 12.11 Leakage at a top gate sill -- Trent and Mersey Canal (PFP)

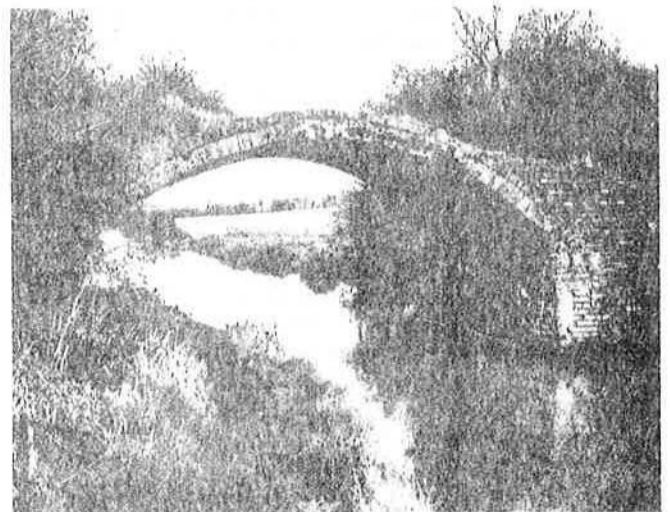
Plate 12.12 Derelict accommodation bridge -- Oxford Canal (South) (PFP)

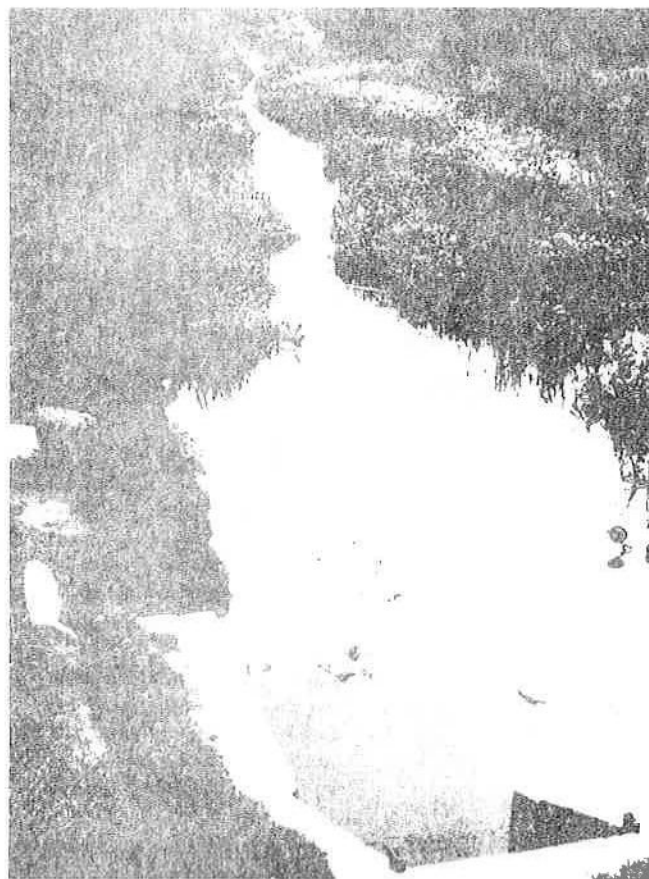
Plate 12.13 Heavy weed growth on the Chesterfield (Remainder) Canal which is a feeder to the Cruising length. (PFP)

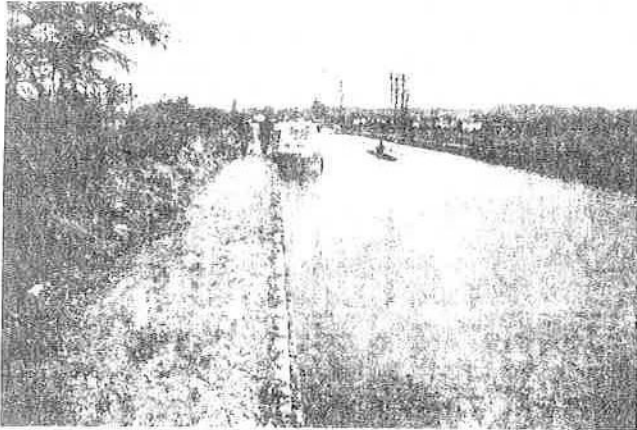
Plate 12.14 Towpath surface formed by granular back-fill material at a linear mooring site on the Grand Union Canal. (PFP)

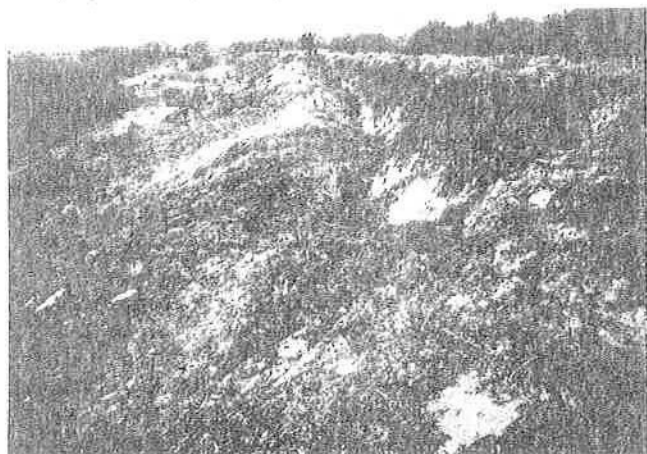
Plate 12.15 Embankment slip at New Bradwell on the Grand Union Canal, January 1975. (PFP)
